International Boundary and Water Commission
United States and Mexico

Report of Transboundary Bypass Flows into the Tijuana
River

Minute 320 Binational Technical Team

Final Report

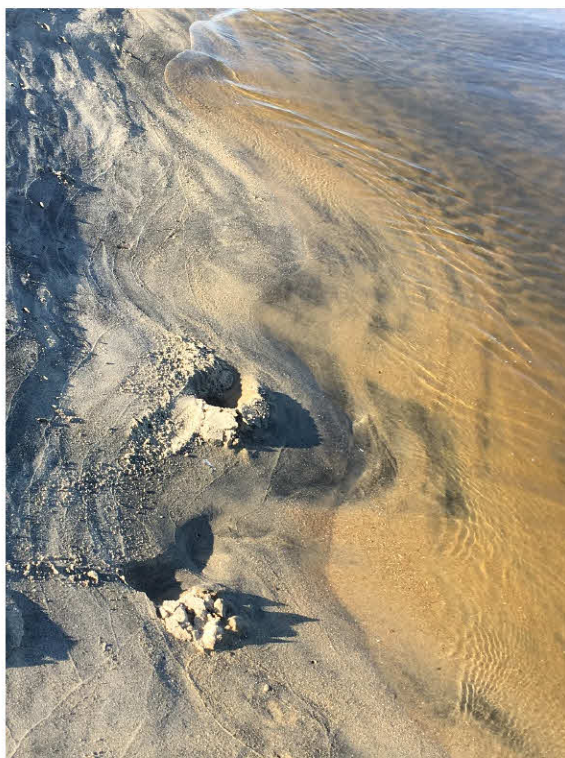
Figure 3 Tijuana River at confluence with Pacific Ocean, dark material present -March 8, 2017

There was the presence of black organic material in the sands. USIBWC interviewed personnel at the Tijuana River National Estuarine Research Reserve and at Border Field State Park, located near the river's mouth. Those personnel noted that the odor of wastewater is consistent when there are flows in

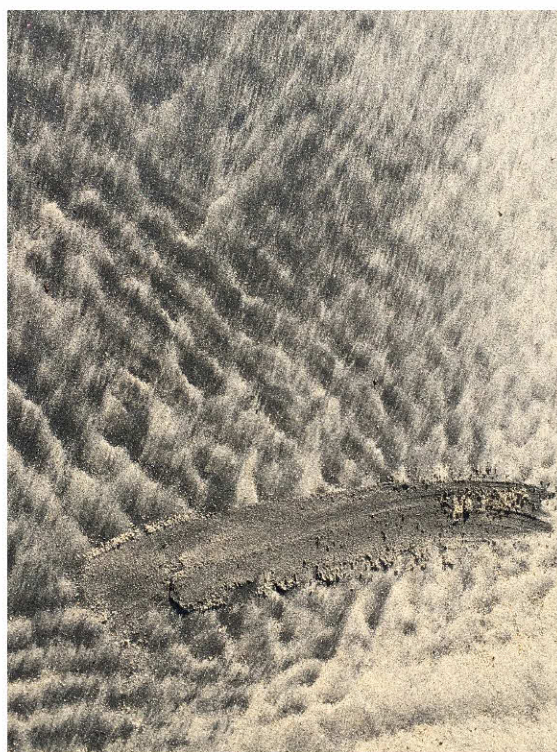
Figure 4 Close up of sand material – March 8, 2017

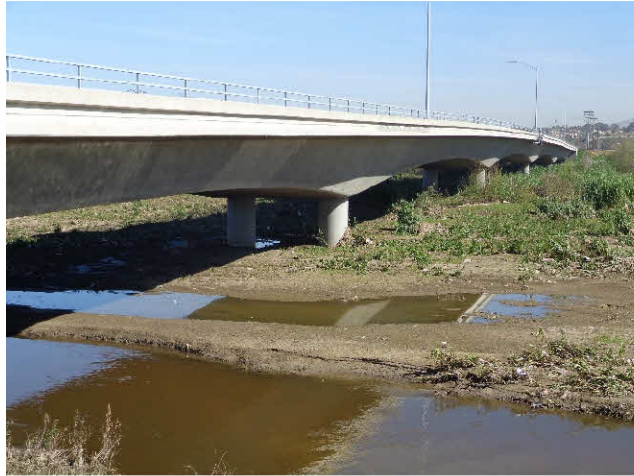
the river and that odors were noticeably higher during early February. Park service personnel noted the increase in odors but they indicated the odors are normally present when the river is flowing. They did not associate the increase with increased wastewater discharges. Park personnel take water quality readings on a routine basis. The Tijuana River flow at Dairy Mart Road Bridge, San Diego California, was slow moving and contained litter but did not smell of wastewater nor have any dark discoloration.

Figure 5 Tijuana River at Dairy Mart Bridge

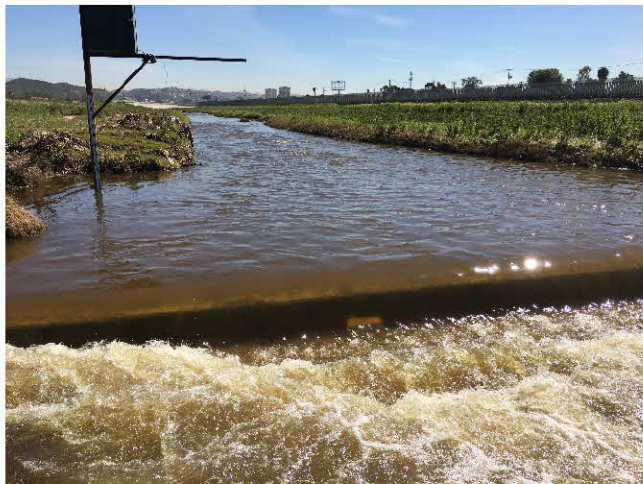
Figure 6 Tijuana River at IBWC gaging station, March 8, 2017

Further upstream at the USIBWC gaging station located in the pilot channel of the flood control project, immediately downstream of the international border, flow of the Tijuana River was fast moving and approximately two cubic meters per second (cms). The flood plain on either side of the pilot channel contained large amounts of trash and debris such as plastic bottles and tires. The water did not smell of wastewater but was slightly brown in color.

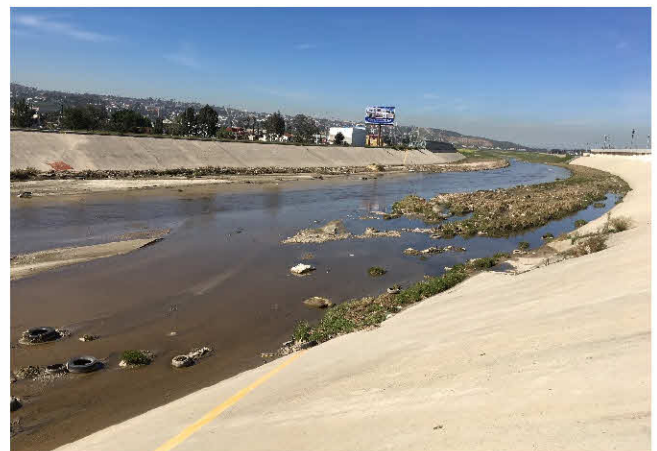
Figure 7 Tijuana River at international boundary- March 8, 2017

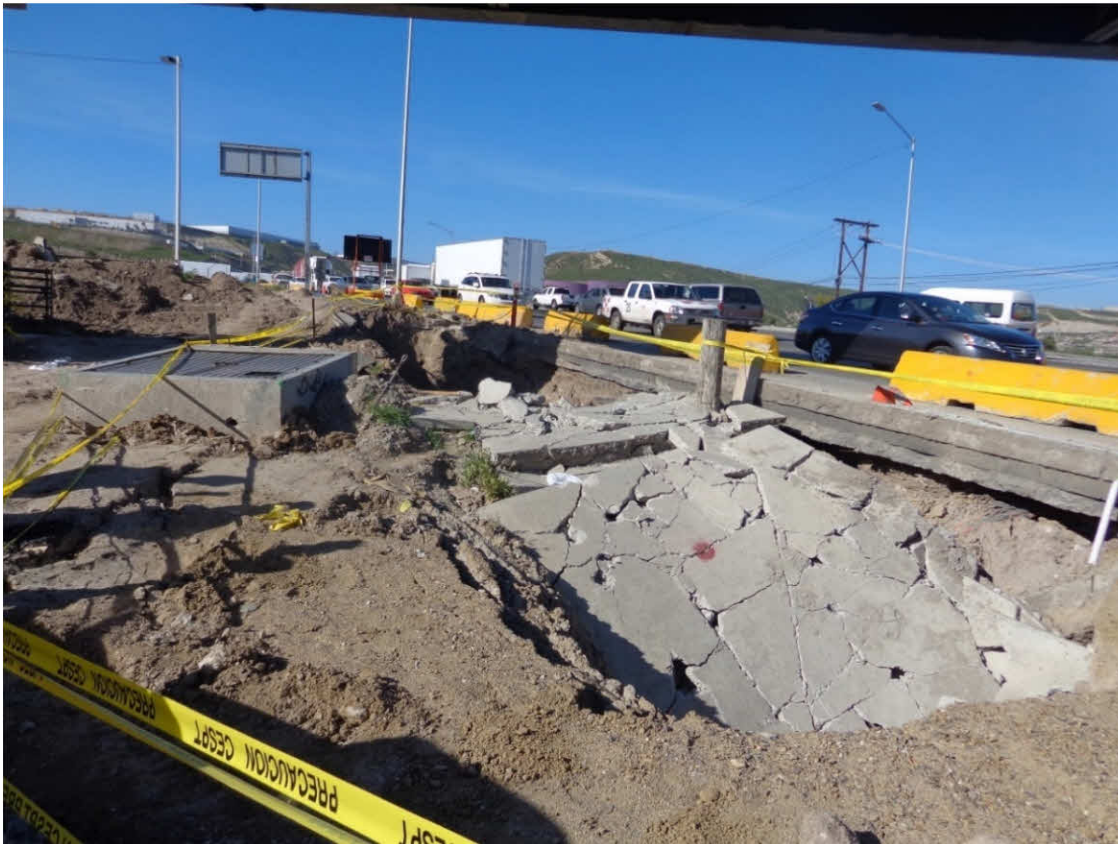
Many of the meeting participants went to the site of where the sinkhole had formed due to the collector break. The site was covered and the bus stop that had fallen in to the sinkhole had been replaced. CESPT showed everyone where the break had occurred and where the bypass had sent water to the *Poniente* collector which runs along the north side of the Rio Alamar. CESPT noted that at that location there is a 40-inch line and a 42-inch line connecting to the junction box that sends the combined flow down a 60-inch line. The area downstream of the junction box has also collapsed and this 60-inch line will need to be repaired in the upcoming dry season. Below is a photo of that area.

Figure 10 Additional damage along roadway due to collector collapse downstream of junction box- Blvd Lazaro Cardenas, Colonia Los Pirules, Tijuana, B.C. - March 9, 2017

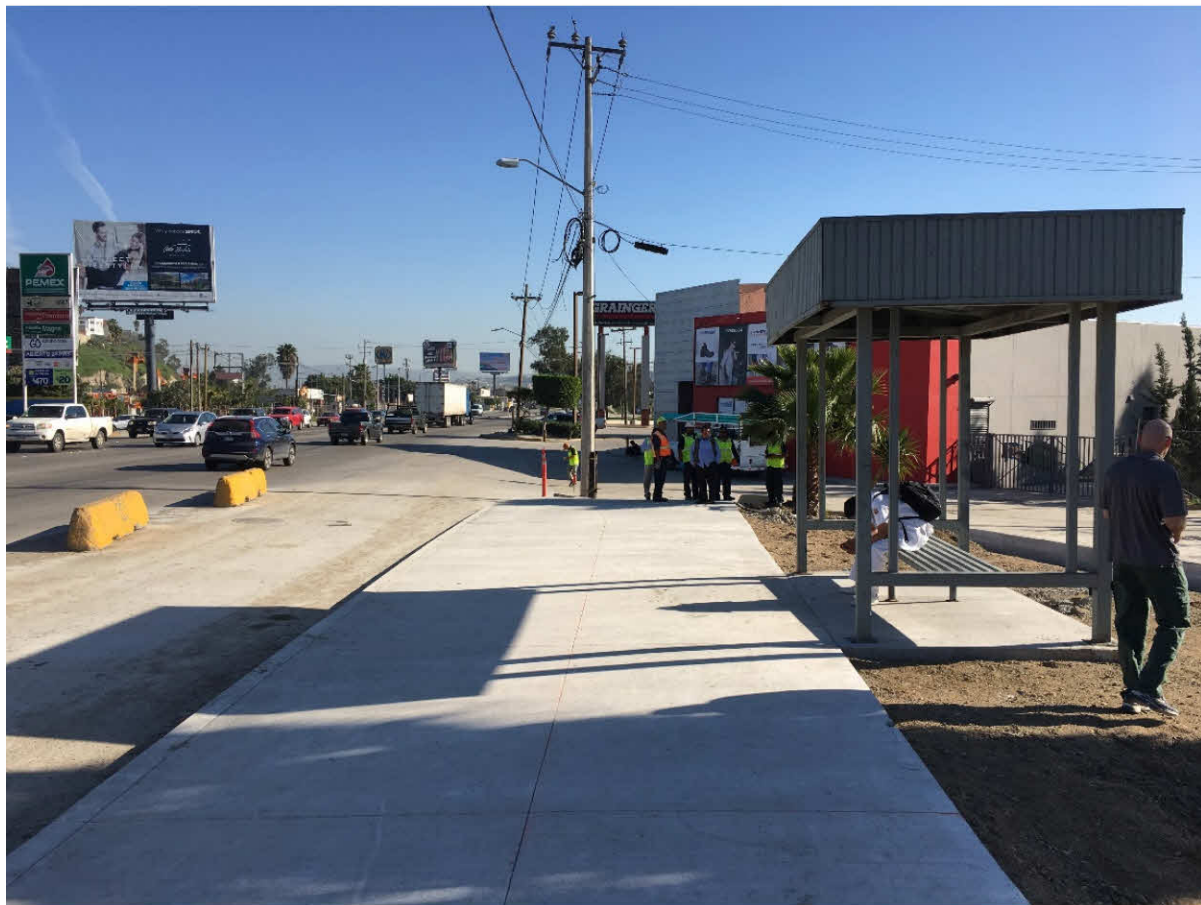
Figure 11 Final repairs to road and bus stop and location of Insurgentes/Oriente collector repair- - Blvd Lazaro Cardenas, Colonia Los Pirules, Tijuana, B.C. - March 9, 2017

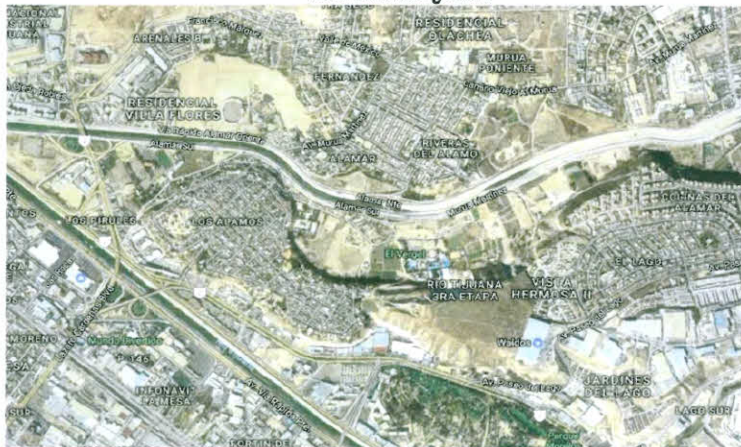
Colector Insurgentes

- COLAPSO EN COLECTOR INSURGENTES
- DESVIOS TEMPORALES A PLUVIALES

EL 17 DE ENERO, COMO PARTE DE LOS TRABAJOS PRELIMINARES A LA REPOSICION DE LA TUBERIA COLAPSADA DEL COLECTOR INSURGENTES, SE INSTALO BY-PASS DE PCV DE 6" PARA ENCAUZAR EL FLUJO REMANENTE HACIA EL INTERCEPTOR ORIENTE

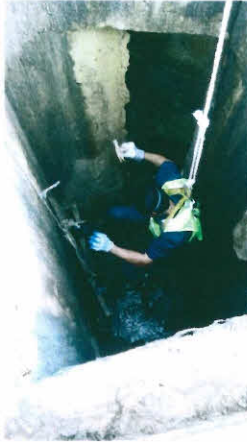
EL DIA 02 DE ENERO DEL 2017, SE TRABAJO EN LA INSTALACION DE UN TAPON INFLABLE DE 24"-48" DE DIAMETRO EN LA CAJA DERIVADORA DEL COLECTOR PONIENTE UBICADA SOBRE EL BOULEVARD FEDERICO BENITEZ ESQUINA CON EL BOULEVARD LAZARO CARDENAS, DE LA COL. LA MESA, EL CUAL SE REALIZO CON EL OBJETO DE ELIMINAR EL 100% DE LAS APORTACIONES CONDUCTIDAS A TRAVES DEL COLECTOR PONIENTE HACIA EL COLECTOR ORIENTE. LO ANTERIOR COMO MEDIDA PREVENTIVA Y PARA EVITAR DERRAMES DE AGUAS NEGRAS HACIA LA CANALIZACION DEL RIO TIJUANA, ORIGINADAS POR EL APARENTE COLAPSO DE UN TRAMO DEL COLECTOR ORIENTE DE 60 PULGADAS DE DIAMETRO.

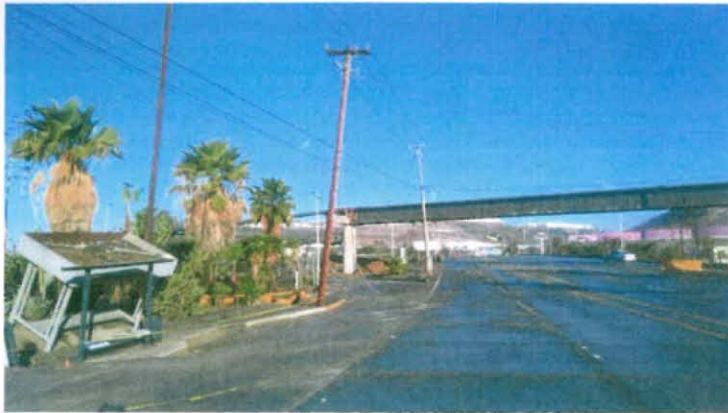
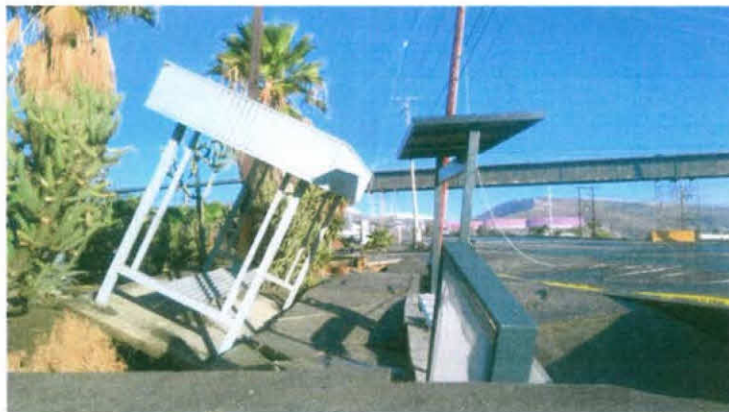
ANTES DEL INICIO DE LA OBRA

Este fue un evento extraordinario, generado por la saturación del colector con agua de lluvia, debido principalmente a las tormentas atípicas en la zona, lo que provocó que la tubería de concreto (ya con vida útil avanzada) trabajara a presión, lo cual dañó en los costados. La tubería fallada tendió a compactarse, reduciendo su área hidráulica e iniciando el arrastre de sólidos del relleno.
