International Boundary and Water Commission
United States and Mexico

Report of Transboundary Bypass Flows into the Tijuana
River

Minute 320 Binational Technical Team

Final Report

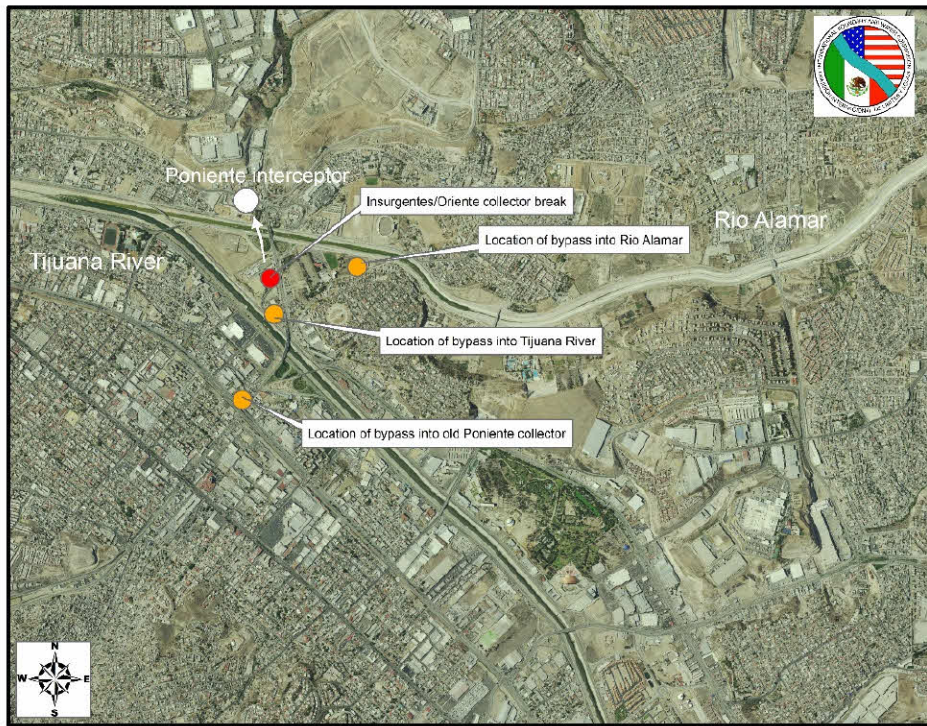
Figure 2 Location of 2017 collector break

On March 1, Roberto Espinosa reported to USIBWC additional details made known at the meeting. On February 1, 2017, there was a collapse of the 48-inch diameter *Insurgentes/Oriente* Collector in the vicinity of the confluence of the Alamar River and Tijuana River. Emergency repairs were undertaken but they were compounded by rain, abandoned underground structures, the failure of a new bus shelter, and overhead and buried power lines. Base flow in the collector was diverted to other pipes, however peak flows were diverted to the river. The nature of the repairs and the expansion of the civil footprint led to a protracted period of repair. The repair work was completed on February 23, 2017. CESPT confirmed their failure to notify the MXIBWC of the emergency work and bypassing of wastewater flows to the river, for that reason, MXIBWC could not provide an estimate for the volume of bypassed wastewater. CESPT also noted that the failure points to the problem of aging infrastructure. CESPT spent \$5 million pesos (MXN), approximately \$260,000 (USD) on repairs, and estimates a need for replacement of approximately two km of 42-inch diameter collectors in the vicinity which will cost around \$28 million MXN, approximately \$1.5 million USD. An additional seven km of pipeline installed in the 1980s are in critical condition and in need of replacement. The Mexican Section stated that they will be coordinating with the State of Baja California to improve CESPT's notification and coordination process.

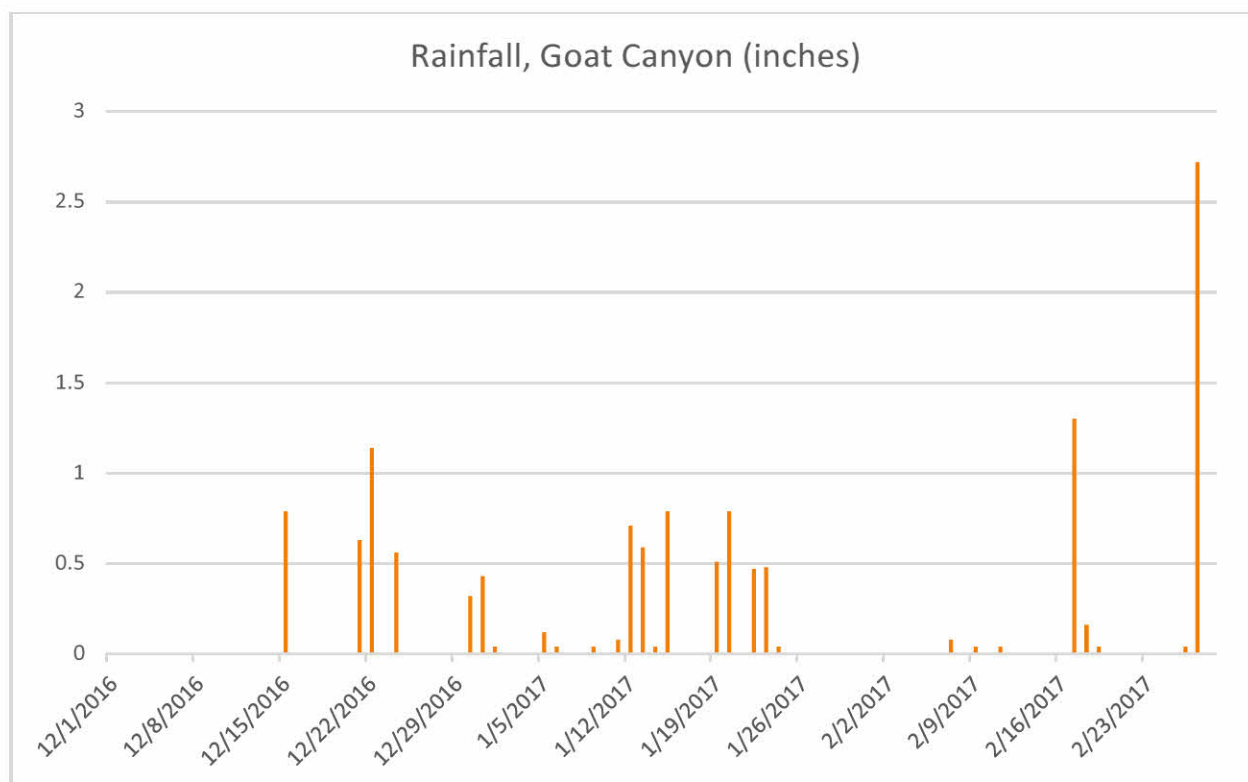
Figure 8 Rainfall data at Goat Canyon (inches)

Starting in mid-December, 2016, storm water flow saturated the area and a portion of the storm water flow entered the wastewater system causing wastewater system overflows in many areas, which flowed to the Tijuana River. Wastewater enters the sewer system through infiltration, and from manholes that are opened by people wanting to drain areas near their residences. CESPT identified seven areas in the wastewater collection system that sustained some degree of damage. Six were repaired and were operational and there had been no discharges of wastewater from these pipelines. The following table is a list of the six locations and the dates of occurrence.

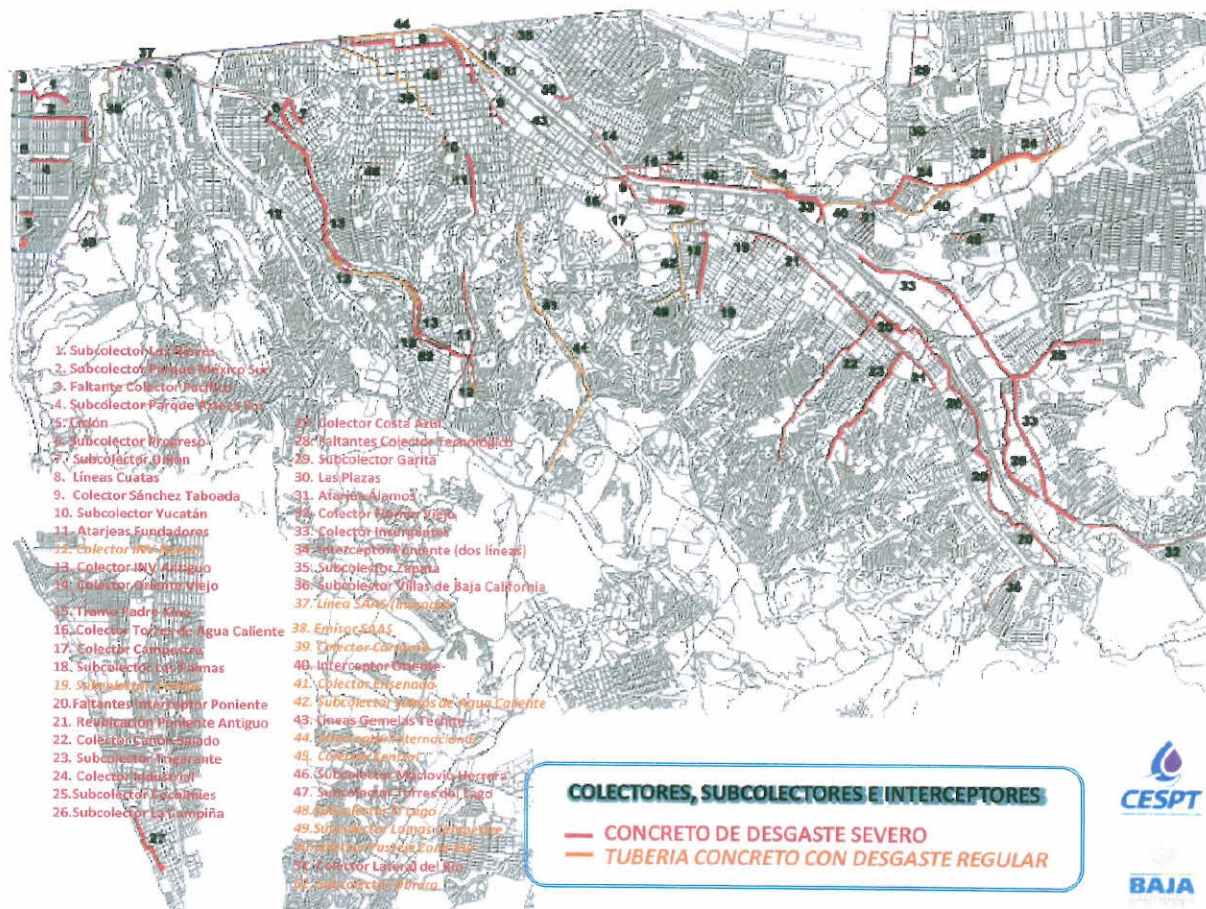
Figure 9 Location map of critical collectors

CESPT noted that they have a 2012 master plan for infrastructure improvements however it needs to be updated as Tijuana has grown significantly. A CESPT consultant will provide the updated 2012 plan with actions and a schedule. CESPT is working with CONAGUA and the governor of Baja California to financially assist in replacing some of the wastewater lines. The following are a location map and two tables showing the immediate needs and near term needs for Tijuana sewerage:

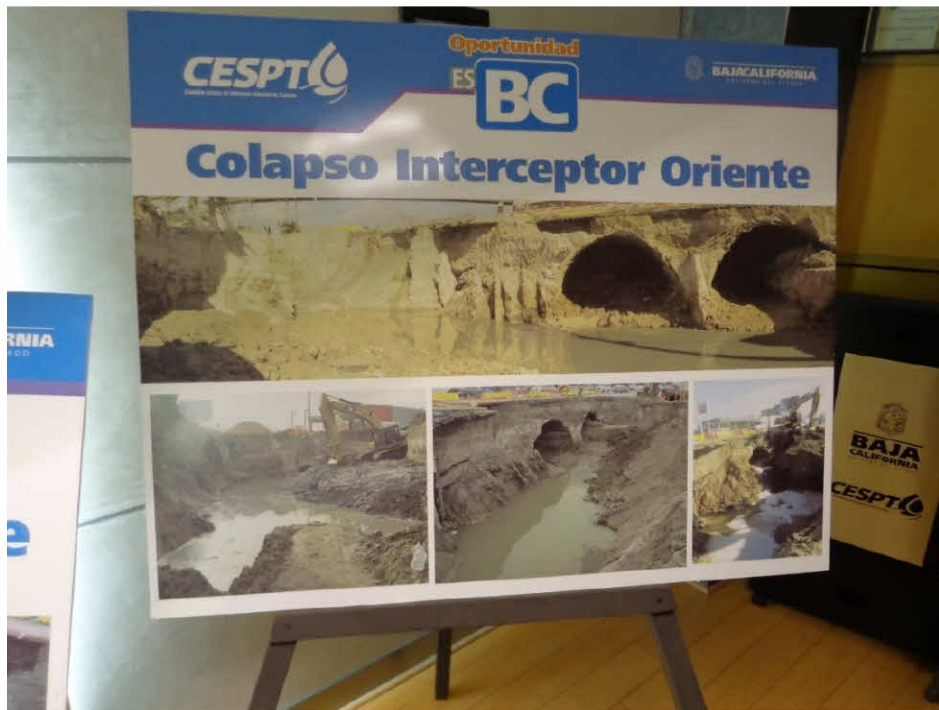
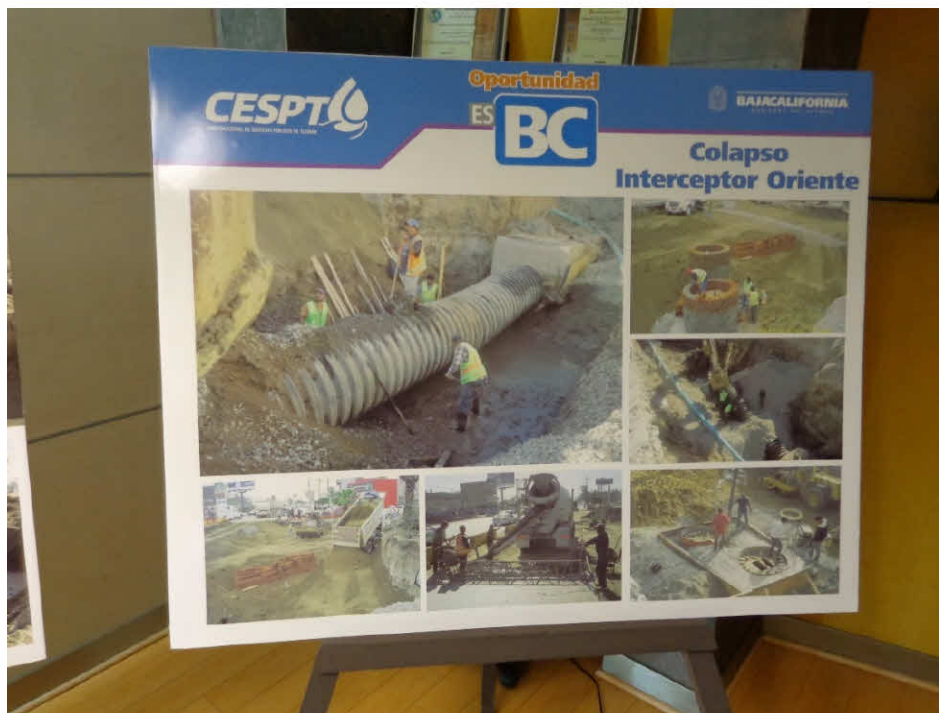
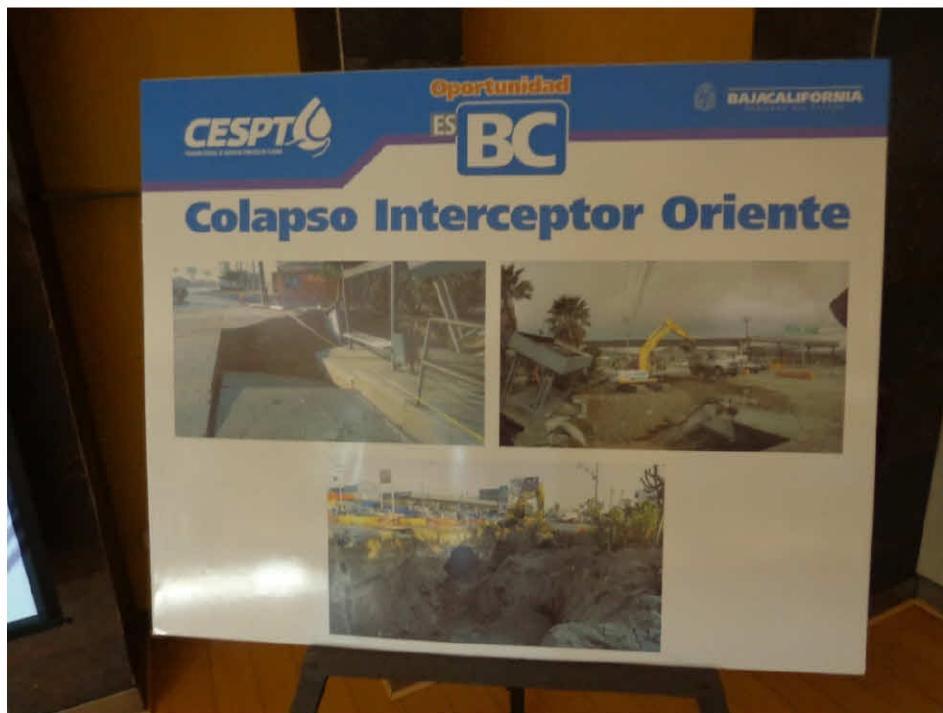
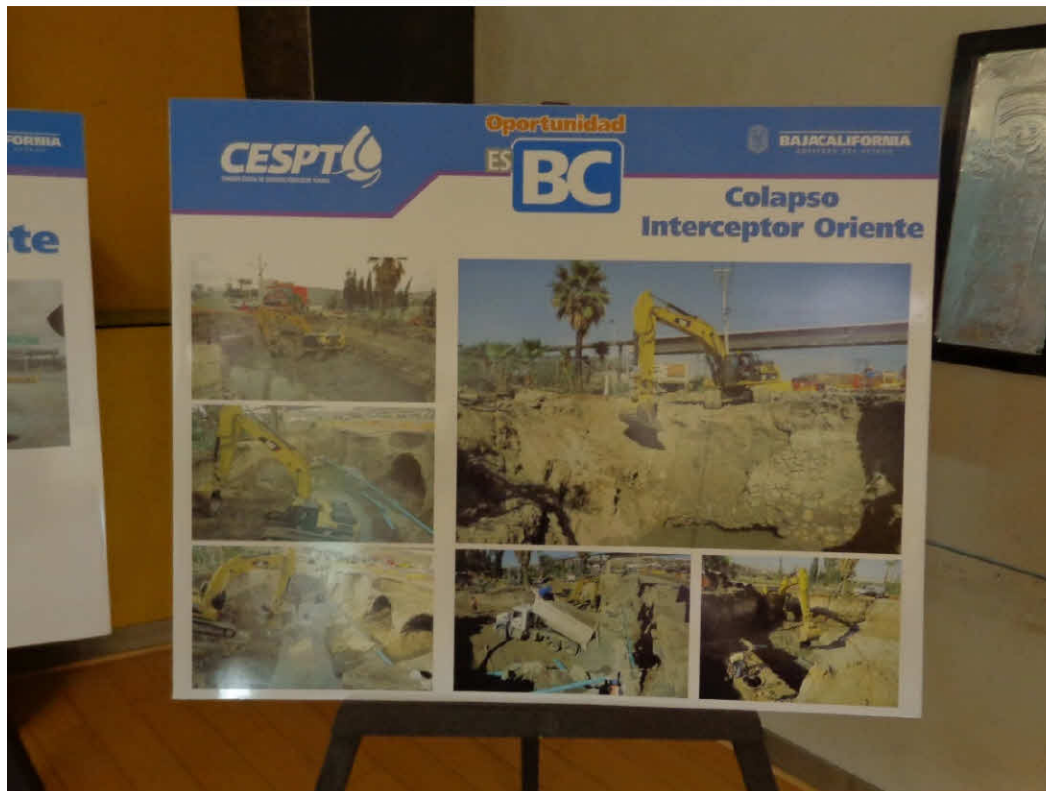
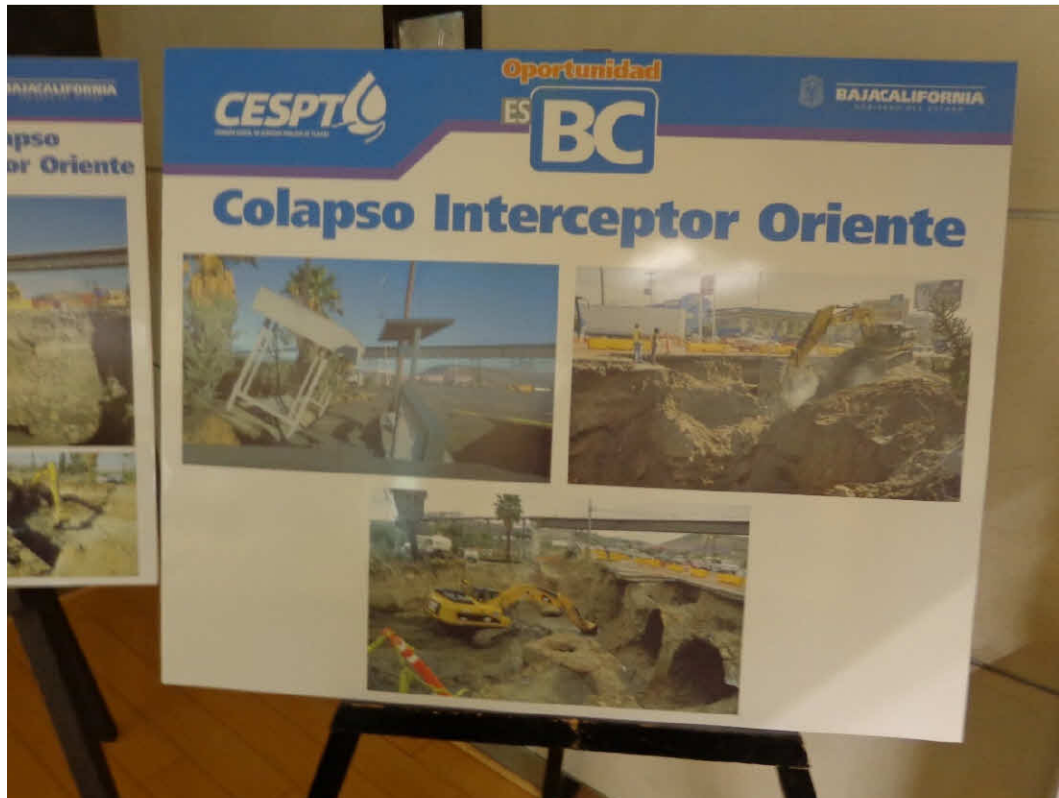
Photographs displayed during the March 9, 2017 meeting at CESPT offices are shown below:

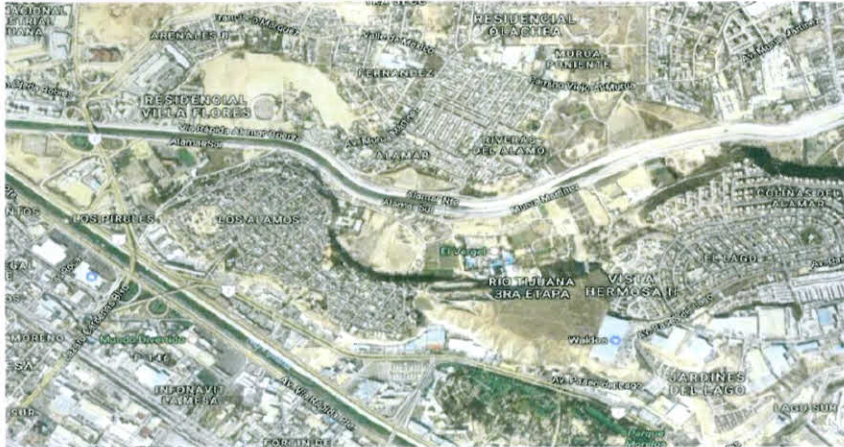
EL 17 DE ENERO, COMO PARTE DE LOS TRABAJOS PRELIMINARES A LA REPOSICION DE LA TUBERIA COLAPSADA DEL COLECTOR INSURGENTES, SE INSTALO BY-PASS DE PCV DE 6" PARA ENCAUZAR EL FLUJO REMANENTE HACIA EL INTERCEPTOR ORIENTE

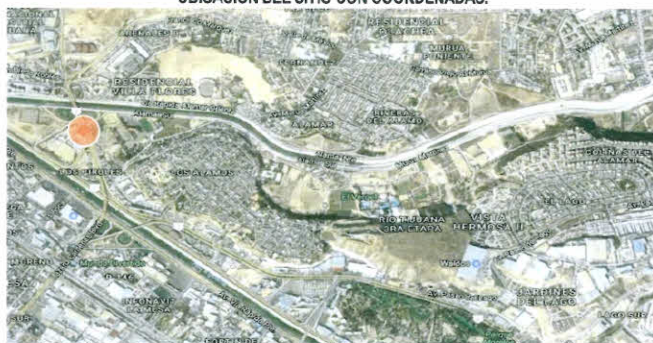
UBICACION DEL SITIO DONDE SE ORIGINO EL COLAPSO COORDENADAS X=503° 583 Y= 3, 597 ,321

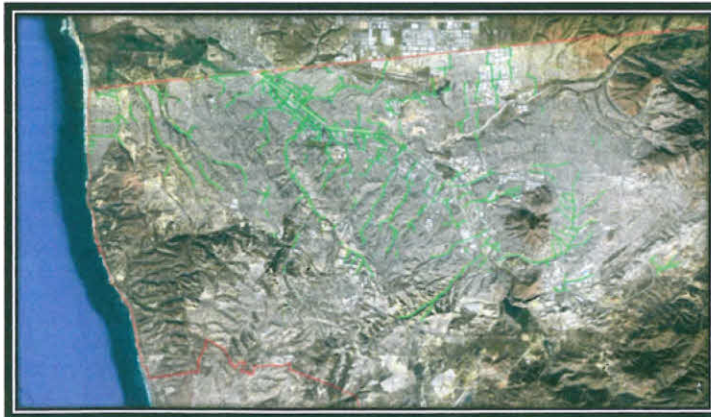
Distribución de la Red del Sistema Pluvial en la Ciudad de Tijuana 2008

Existe en la ciudad un reducido sistema de drenaje pluvial que funciona de manera limitada, sin embargo donde no existe, es frecuente observar en situación de lluvia, a personas abriendo tapas de alcantarillado sanitario para desfogar los escurrimientos pluviales de las calles, introduciendo dicho caudal y sumarse al que conducen las líneas sanitarias. También es frecuente observar en las viviendas que las personas instalan rejilla y tubería para captar el escurrimiento pluvial de los patios hacia el drenaje sanitario interno. Adicionalmente, se han detectado conexiones de las alcantarillas o bocas de tormenta al sistema de drenaje sanitario. Todas estas conexiones consideradas indebidas ocasionan en época de lluvias severos problemas en la red, ocasionando desbordamientos en los sitios donde no se tiene la capacidad de conducción, ya que como se mencionó anteriormente los sistemas se proyectan para que funcionen en forma independiente. Los desbordamientos se manifiestan por el vertido del agua a través de las tapas de los pozos de visita sanitario. Es recurrente observar que es en las zonas bajas de la ciudad, donde se combina la poca pendiente de las tuberías, los desbordes mencionados. Aparte de la saturación de la tubería por el caudal que conduce al sumarse agua de lluvia como la propia residual, también se azolvan las tuberías y el mantenimiento que se requiere supera la capacidad de respuesta del Organismo.

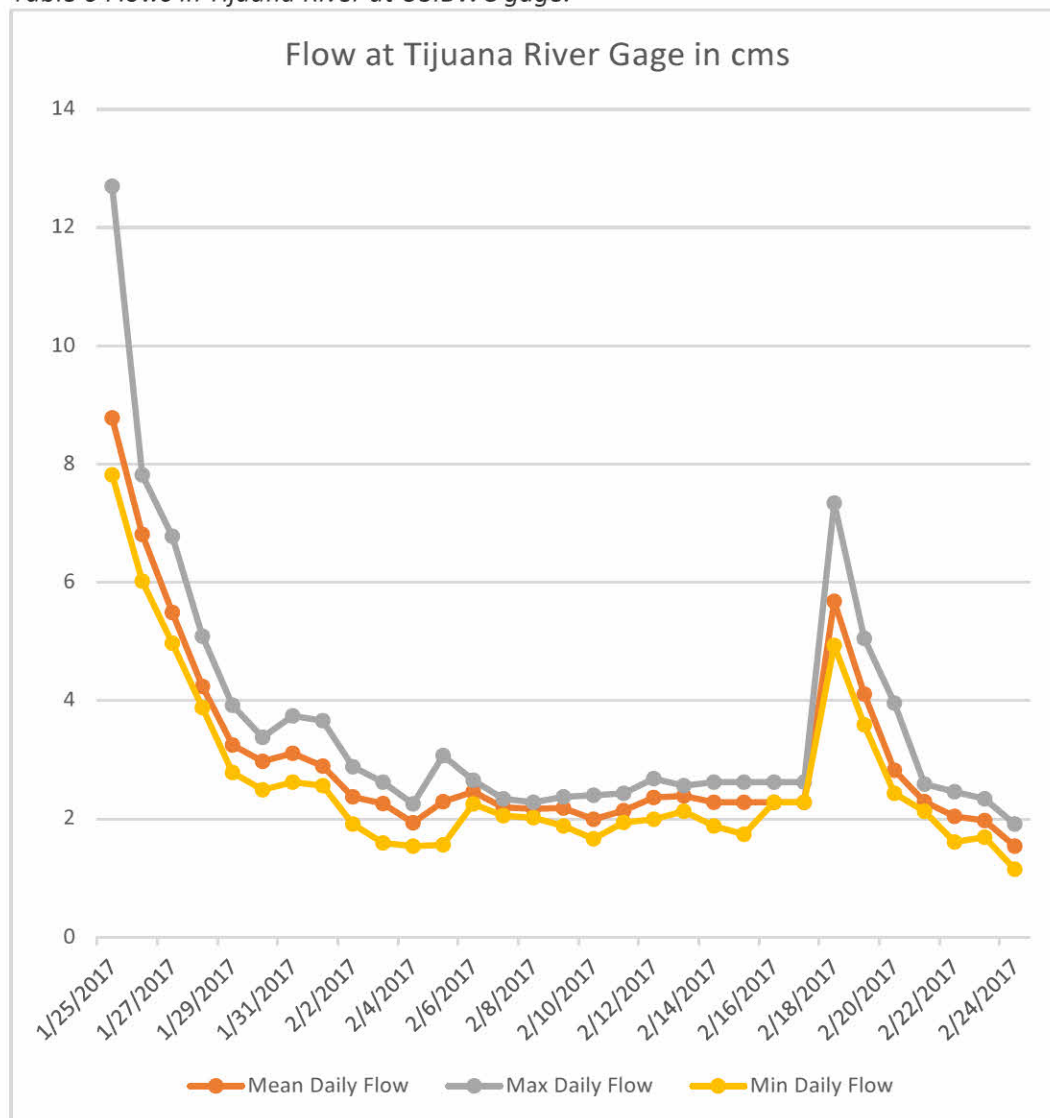
Table 6 Flows in Tijuana River at USIBWC gage.

Tijuana River gage information for late January and February 2017 obtained from the Yuma office of the IBWC. The Yuma office is responsible for digitizing the chart for the gauge and developing minimum, maximum and average daily flows for the official record. The gage is a standard bubbler gage with chart recorder, but is subject to trash and sediment deposition which can have an effect on reported gage height. The gage has an accuracy of $\pm 5\%$ and is not efficient to measure low flows, due to silt and solids. Below is a plot of the flow from January 19, 2017 to February 26, 2017 which includes the spill period in question. The February 1, 2017 to February 4, 2017 event is clearly indicated with an increase in flow during a dry period without rainfall. One large rain event occurred on February 18 (Data for February 17, 18 and 19, 2017 was changed to lower values to emphasize low flow data on the vertical scale of the graph. Flow in the river on February 18, 2017 peaked at 318 cms). Normally after a storm, the flows will gradually decrease and asymptotically reach an equilibrium level (or zero) without additional increases. The gauge information seems to indicate additional flow beyond the normal amount in the February 7 through 16, 2017 period, however this is coupled with a small rainfall event on February 7, 2017 (0.19 inches at Brown Field Municipal Airport in California, U.S.) From the graph it appears that after the large runoff event on February 18, 2017 the flow dropped below that seen during the February 7 through 16, 2017 period. One would expect the base flow to be higher after a major event such as that of February 18, 2017 than the base flow before the event, yet that does not appear to be the case.

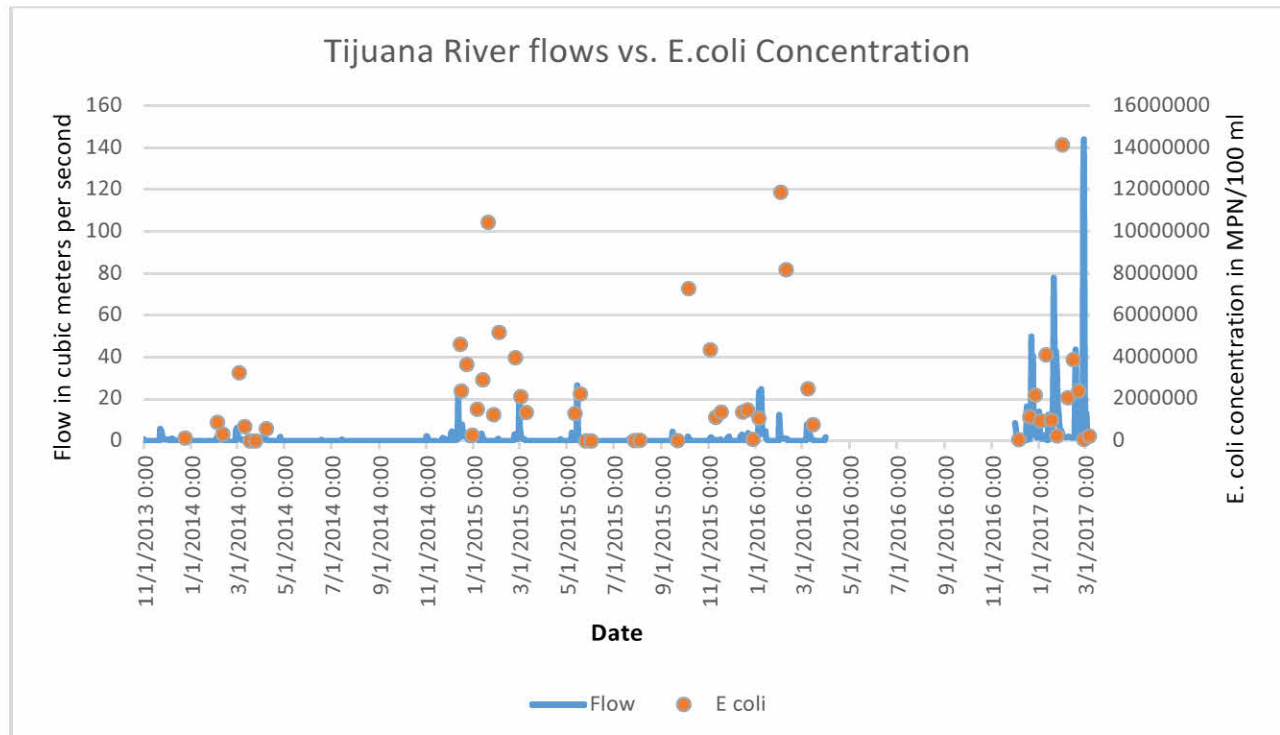
Table 7 E. coli levels and flow at Dairy Mart Road Bridge taken by USIBWC, period of record.

The first plot (Table 7) is all the historical data since 2013 and the second plot (Table 8) shows the data for the December 2016 through February 2017 period. It appears from the data presented in Table 8 that there was a component of municipal wastewater in the river from December 15, 2016 on, with highest levels on January 31, 2017. This also indicates that untreated wastewater had entered the Tijuana River at high volumes prior to the February 1 to February 4, 2017 spill.

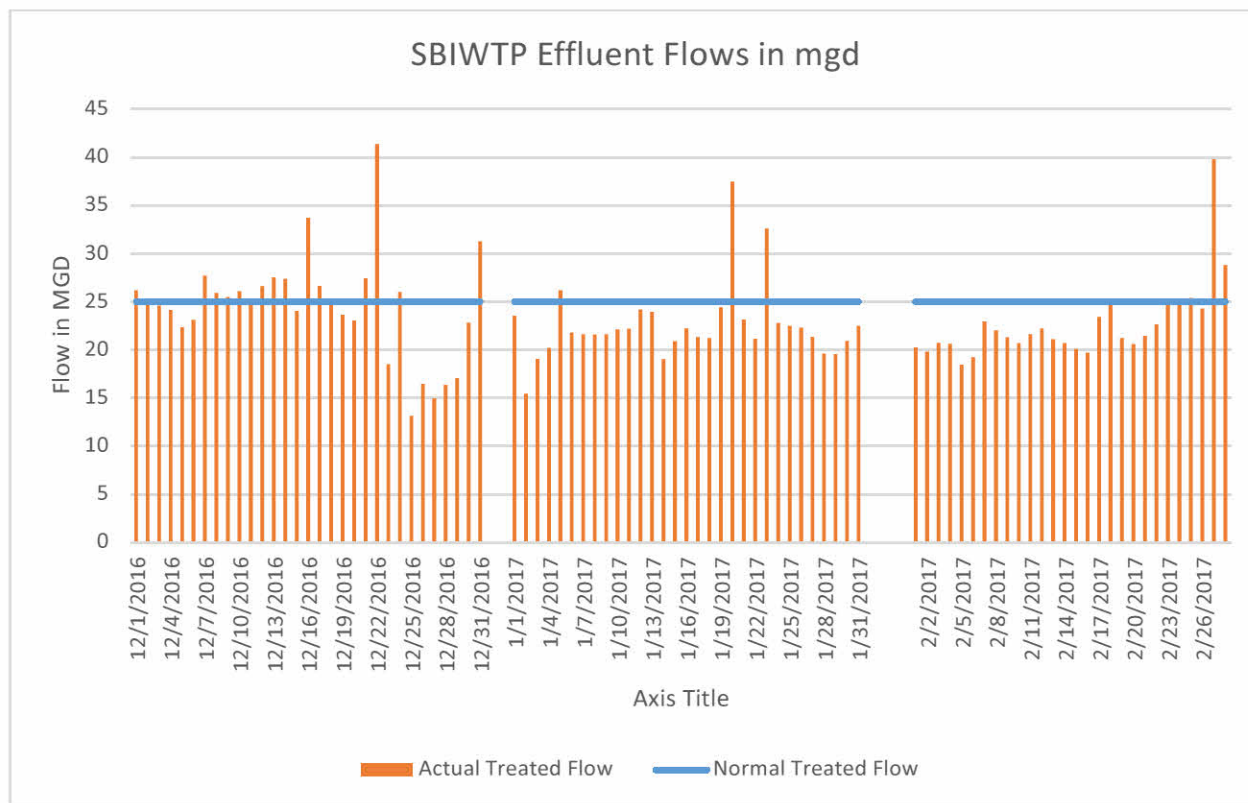
Table 9 2016-2017 flows treated at SBIWTP.

Below is a graph showing wastewater flow to the SBIWTP. The plant strives to maximize treatment of a flow between 24-25 million gallons per day (mgd), averaged over a month. Below is a graph of the flow to the SBIWTP for December 2016 through February 2017. Average flow during the last week in December 2016 was 20.7 mgd, during January 2017, 22.5 mgd and during the period February 1 - 23, 2017, 21.2 mgd.
